Date: 1/5/2007	Time: 3:01 PM	Report ID: 010520070900
Property: 123 New House Lane My Town, VA	Customer: Mr. First Time Homebuyer	Real Estate Professional: Joe Realtor Best Real Estate

General Summary

Ken Melton's Homebuyer Inspections

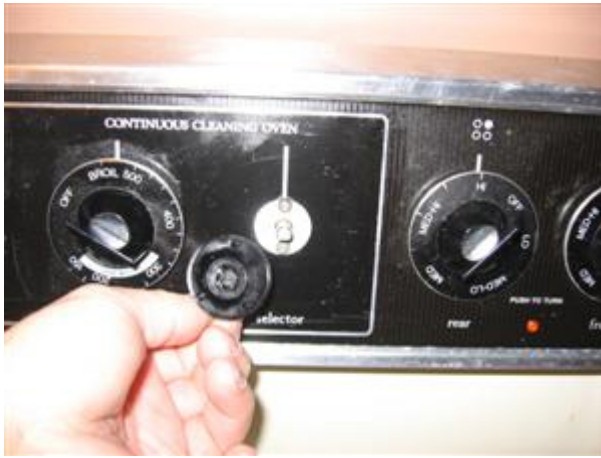
REPAIR OR REPLACE: Control knobs for oven is damaged. Have repaired and retest at walkthrough.

1.0 Picture 1 Bake / Broil Selector

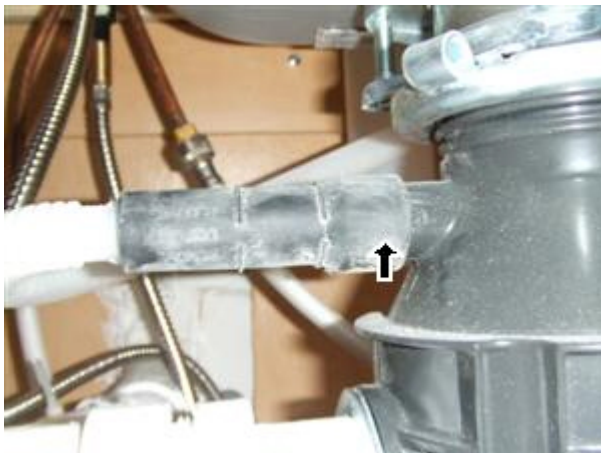
REPAIR OR REPLACE: Dishwasher drain hose is not clamped at the disposal drain connection. This will come loose and flood the cabinet if not corrected. Have corrected by a qualified contractor.

1.2 Picture 1 Viewed from kitchen cabinet

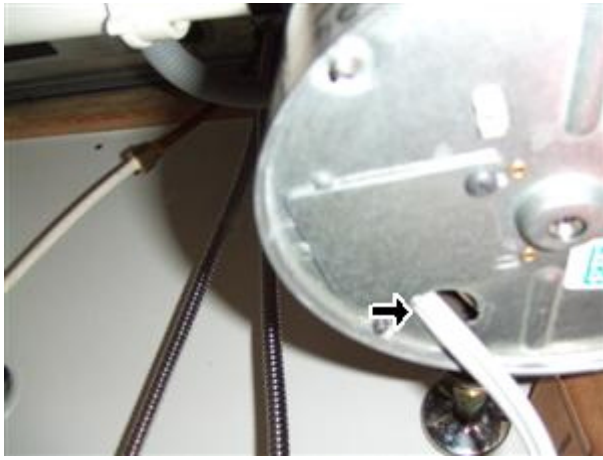
REPAIR OR REPLACE: Disposer wiring is missing romex connector. This is a potential shock hazard. Have repaired by a qualified contractor.

1.3 Picture 1 View of bottom of Food Waste Disposal

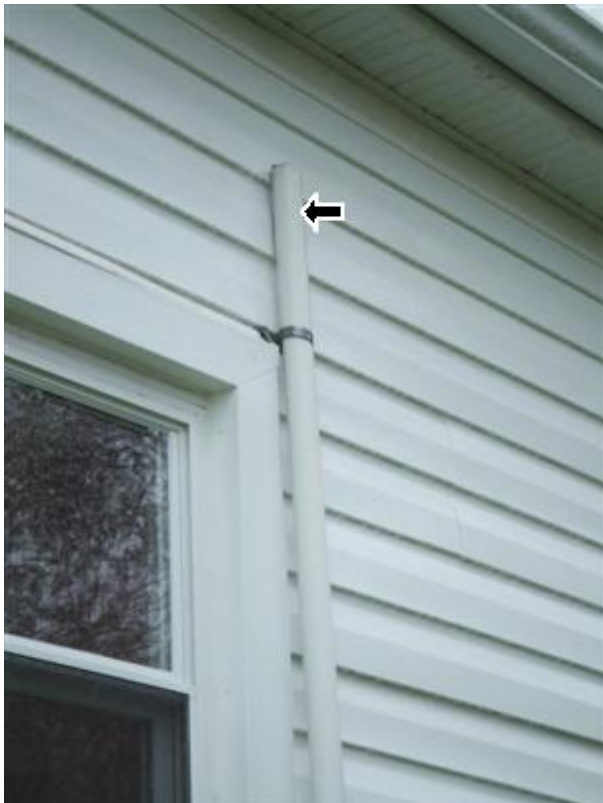
REPAIR OR REPLACE: Plumbing vent terminates near window at rear of home. Vents should terminate above the roofline. Recommend a qualified licensed plumber repair or correct as needed

2.1 Picture 1 Right rear bedroom window

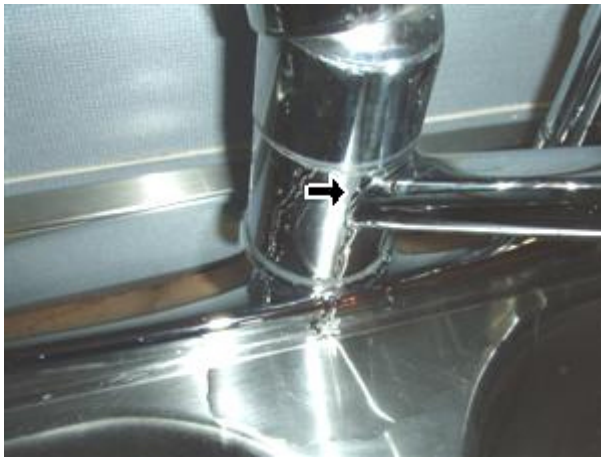
2.2 Picture 1

REPAIR OR REPLACE: Faucet for sink in kitchen leaks at faucet spout swivel. Repairs are needed. Recommend a qualified plumber perform all repairs and retest at walkthrough

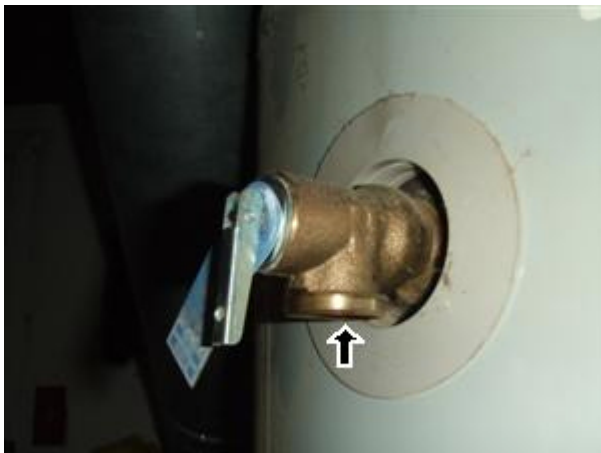
REPAIR OR REPLACE: T&P (Test and Pressure) valve on water heater needs a 3/4 threaded pipe to extend within 6 inches of floor for safety. (PVC is not approved for hot water use). Recommend repair by a qualified person.

2.3 Picture 1 Located in hall closet

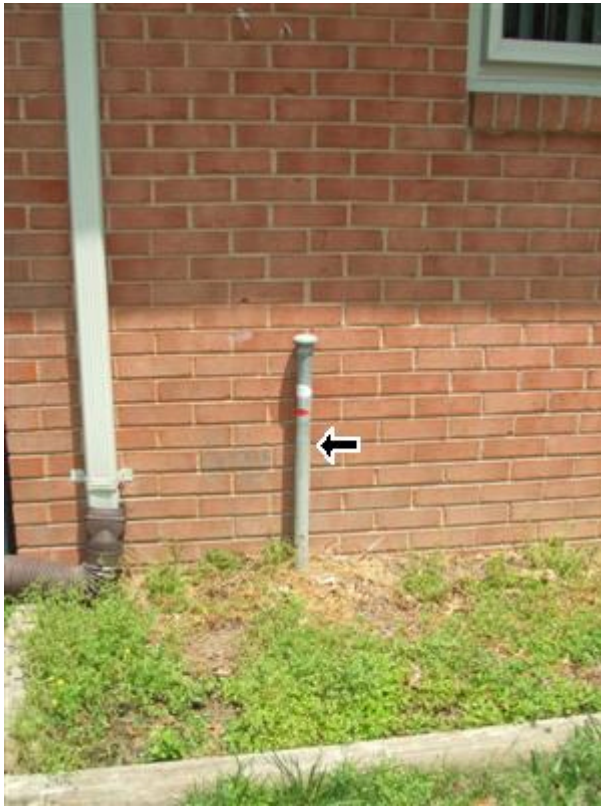
REPAIR OR REPLACE: I did find evidence of an abandoned oil barrel. I did not inspect discontinued oil barrel for leaks or soil contamination. Recommend further evaluation to determine the condition of this barrel.

2.4 Picture 1 Oil tank vent

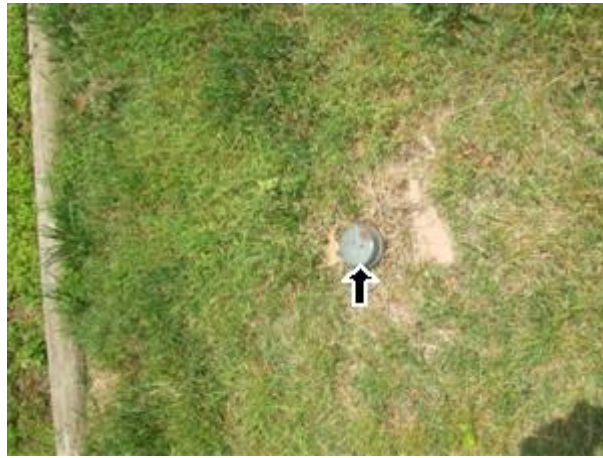
2.4 Picture 2 Oil tank fill cap

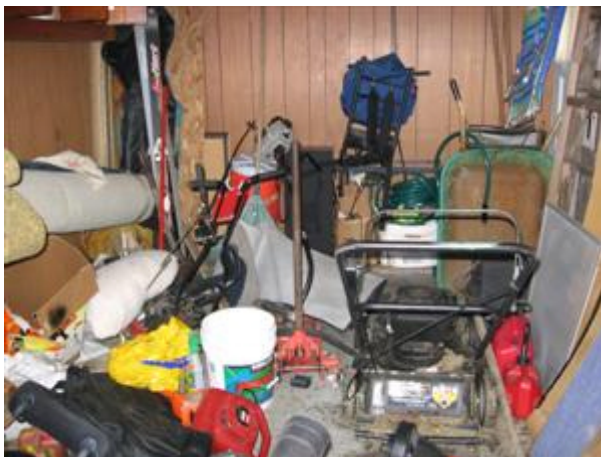
NOT INSPECTED: The left rear bedroom was overly cluttered with the homeowner's belongings and could not be inspected. I recommend that you suggest to the homeowner that you reserve the right to check the room at walkthrough and he would be held accountable for any issues discovered.

3.7 Picture 1 Left rear bedroom

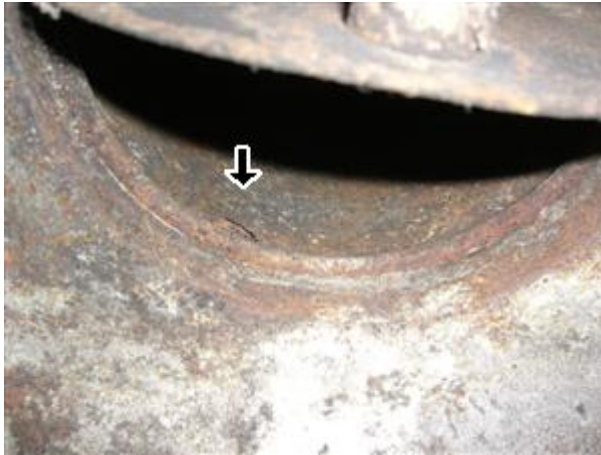
REPAIR OR REPLACE: Metal liner in chimney for Fireplace at Den is rusted out at the bottom. The fireplace should not be used until evaluated / repaired. Recommend a qualified chimney sweep inspect and repair as needed.

4.1 Picture 1 Hole in flue

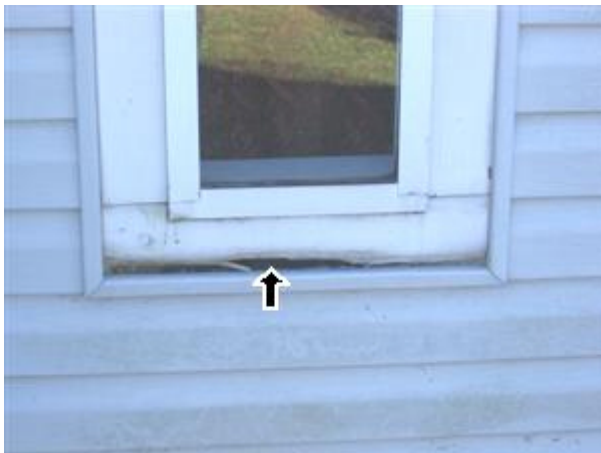
REPAIR OR REPLACE: Wood trim at window at front of home is moisture damaged. Further deterioration may occur if not repaired. A qualified person should further inspect and repair or replace as needed.

5.1 Picture 1 Front bedroom window

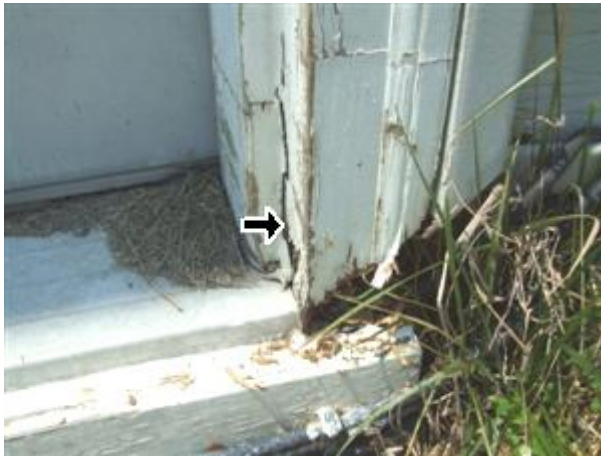
REPAIR OR REPLACE: Side entry door has moisture damaged frame(s) at the bottom. Further deterioration may occur if not repaired. Recommend a qualified contractor inspect and repair as needed.

5.2 Picture 1 Side garage door

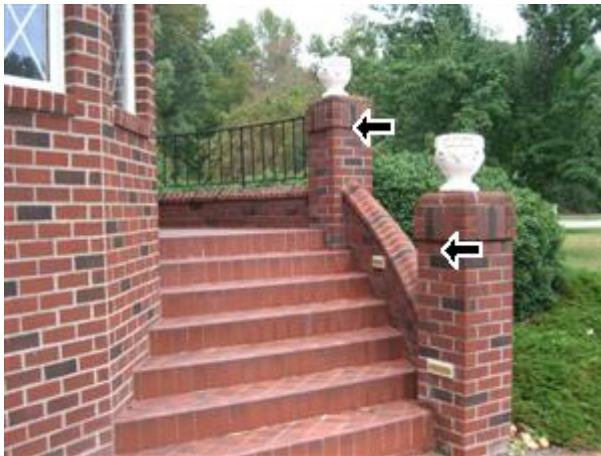
REPAIR OR REPLACE: Handrail missing. A grippable handrail is require if steps have 4 or more risers. Handrail should be located 34" - 38" above steps with a grippable surface of 1 1/4" minimum and 2" maximum. This repair should be accomplished by a qualified contractor to prevent an injury from a fall.

5.4 Picture 1 Front entry

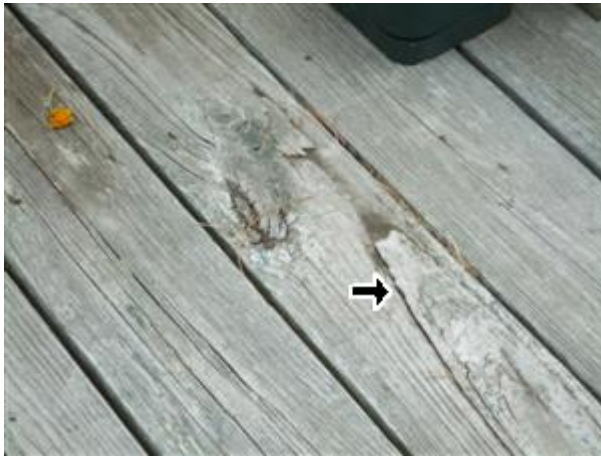
REPAIR OR REPLACE: Decking on Deck at rear of home deteriorated, and needs repair or replace. Many boards are warped and splintered and pose a safety hazard. Recommend repair or replace by a qualified contractor.

5.4 Picture 2 Splintered board

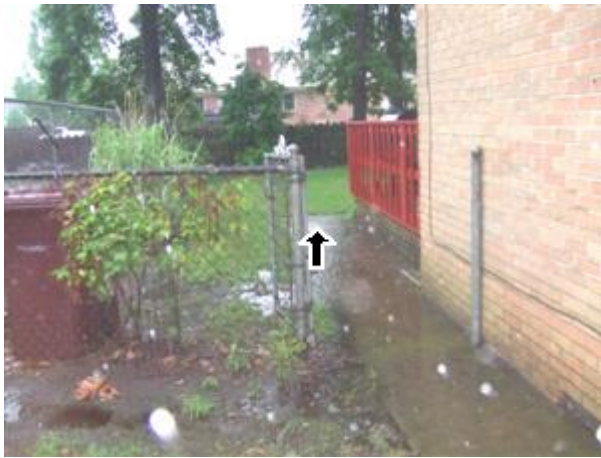
REPAIR OR REPLACE: Negative slope towards left rear corner of the home. This area does drain water away from home and needs landscaping and drainage corrected.

5.5 Picture 2 Standing water 2" deep on walkway

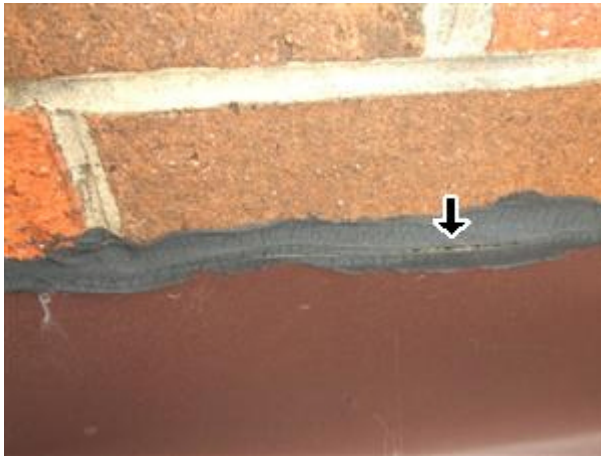
REPAIR OR REPLACE: Flashing has gaps in the caulk at the chimney. This issue should be corrected by a qualified roofing contractor to prevent damage / further damage to the structure.

6.1 Picture 1 Left side of chimney

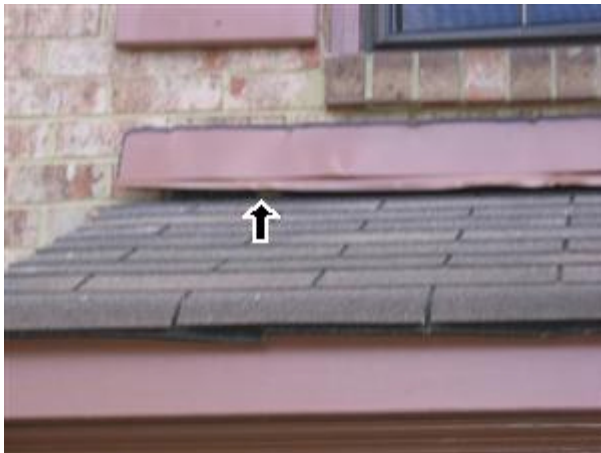
REPAIR OR REPLACE: Flashing is lifted at front. This issue should be corrected by a qualified roofing contractor to prevent damage / further damage to the structure.

6.1 Picture 2 Porch roof

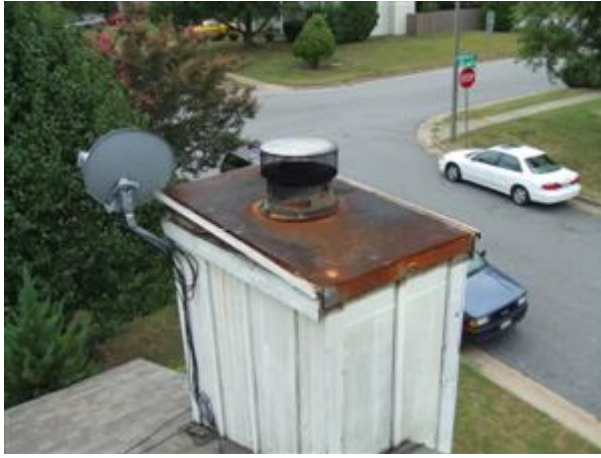
REPAIR OR REPLACE: Metal cover on top of on chimney chase is rusted out. Deterioration may occur if not corrected. Recommend a qualified chimney sweep inspect and repair as needed.

6.2 Picture 1 Severe rusting

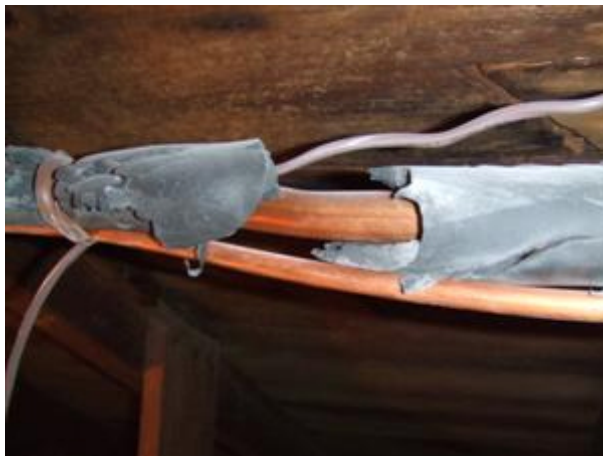
REPAIR OR REPLACE: Foam insulation deteriorated on freon line in attic. Moisture will condense on the bare pipe in the summer and will drip on the ceiling if not repaired. Have corrected by an HVAC contractor.

7.2.B Picture 1 In attic near Air Handler

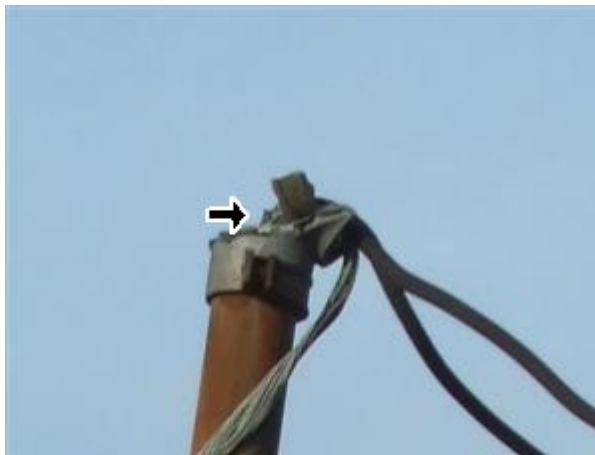
REPAIR OR REPLACE: Problem(s) discovered with Service Entrance Conductors such as the service mast is leaning, the weatherhead on the service mast is damaged, the service entrance conductors are damaged, and the meterbase is not rated for the 200 Amp electrical panel inside the house. These are serious safety concerns. Recommend a licensed electrician inspect further and correct as needed.

8.0 Picture 2 Damaged weatherhead (ground view)

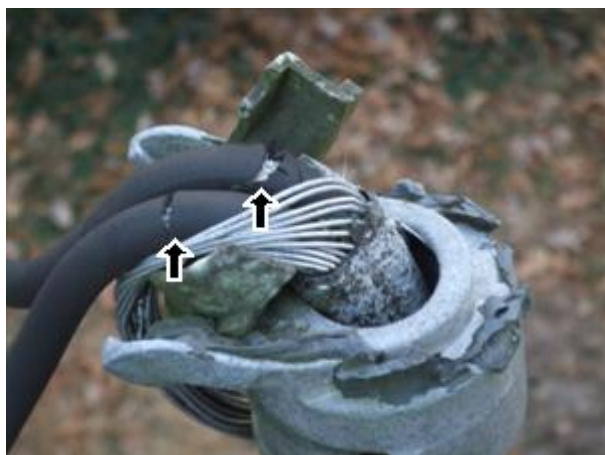
8.0 Picture 3 Split insulation on conductors

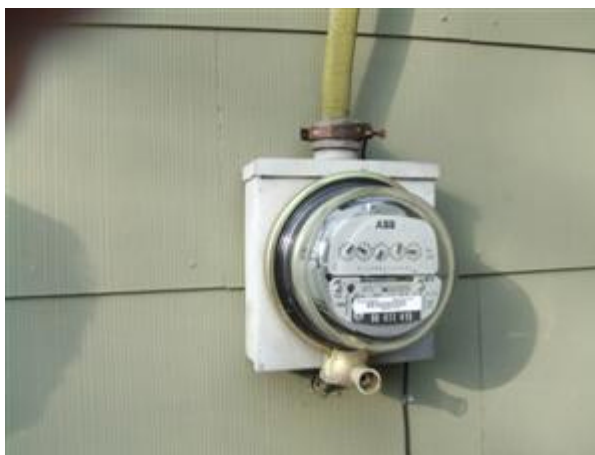
8.0 Picture 4 Meterbase rated for 100 Amps

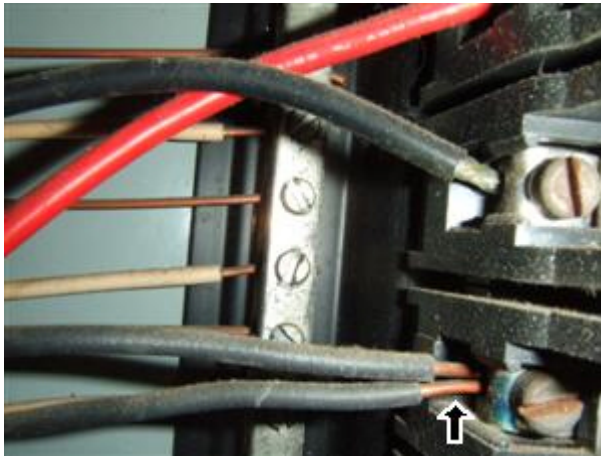
REPAIR OR REPLACE: Problem(s) were discovered in panel such as Doubled tapped wiring at circuit(s).. Electrical issues in panels are considered hazards until repaired. Have further evaluated / corrected by a licensed electrical contractor.

8.1 Picture 1 Breaker #5

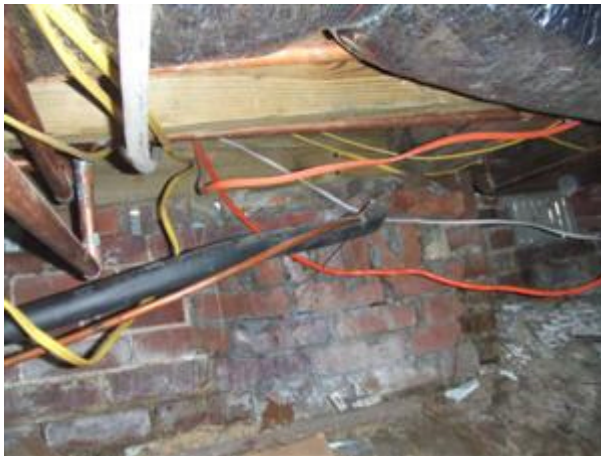
REPAIR OR REPLACE: Wiring in crawlspace is installed in a non workmanlike manner (should be uniformly attached to the bottom of the floor joists). Electrical issues are considered a hazard until repaired. Recommend a qualified licensed electrician perform repairs that involve wiring.

8.2 Picture 1 Beneath utility room in crawlspace

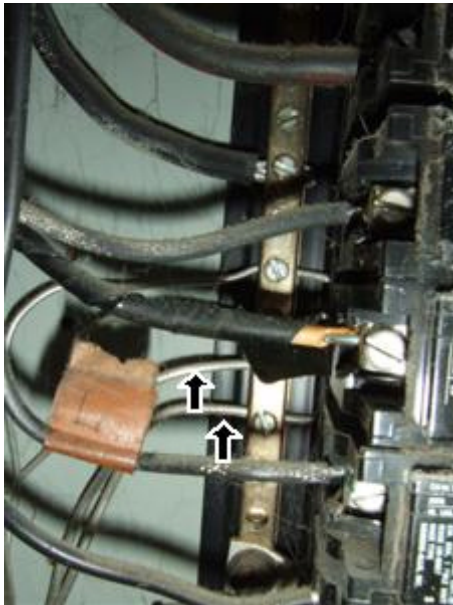
REPAIR OR REPLACE: Aluminum wire is installed on 120 VAC branch electrical circuits in the subject house. These single strand, branch circuit aluminum wires were used widely in houses during the mid 1960s and 1970s. According to the U.S. Consumer Product Safety Commission, problems due to expansion can cause overheating at connections between the wire and devices (switches and outlets) or at splices, which has resulted in fires. For further information on aluminum wiring contact the U.S. Consumer Product Safety Commission via the Internet at <http://www.cpsc.gov/> . It is recommended that the electrical system be evaluated by a licensed electrician.

8.2 Picture 2 Aluminum conductors in electrical panel

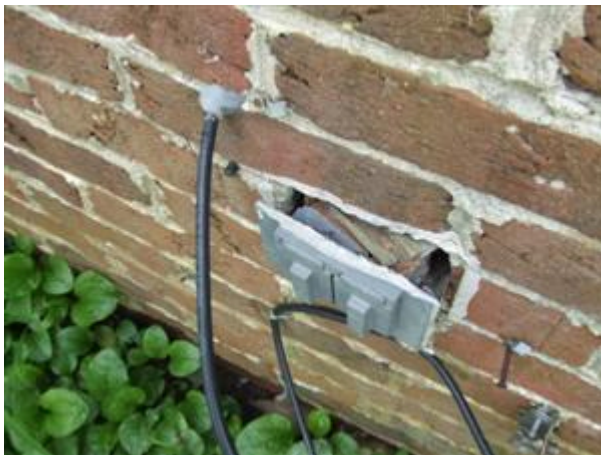
REPAIR OR REPLACE: Outside outlet is loose in wall at the the rear of the home. This is a safety issue that needs to be corrected. Have further evaluated / repaired by an electrical contractor.

8.3 Picture 1 Under kitchen window

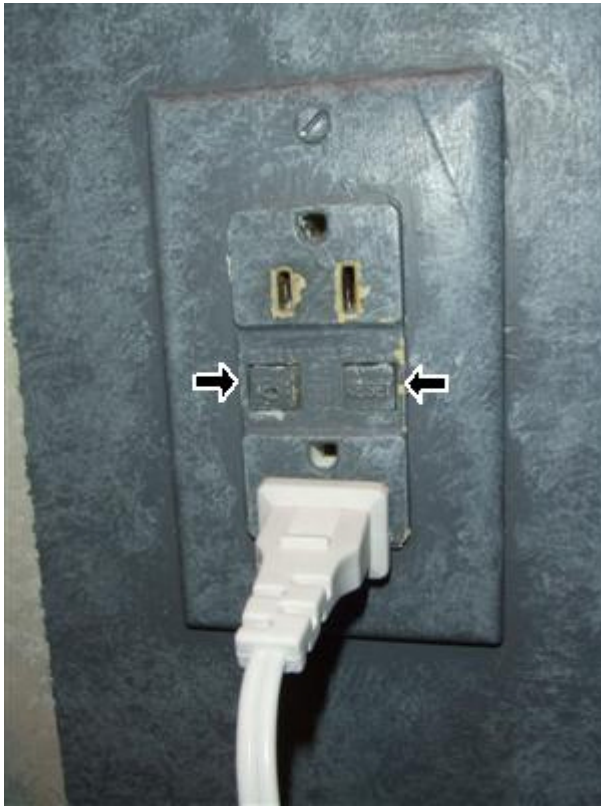
REPAIR OR REPLACE: GFCI (Ground Fault Circuit Interrupter) outlet in the Master bath did not trip when tested (defective). It is painted over. This is a safety issue that needs to be corrected. Have further evaluated / repaired by an electrical contractor

8.4 Picture 1 Button stuck

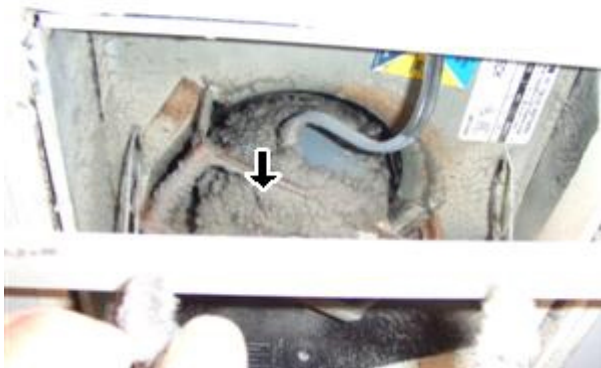
REPAIR OR REPLACE: The Exhaust fan is noisy at the hall bath. The unit is excessively dirty. A qualified person should repair or replace as needed.

9.2 Picture 1 View with cover removed

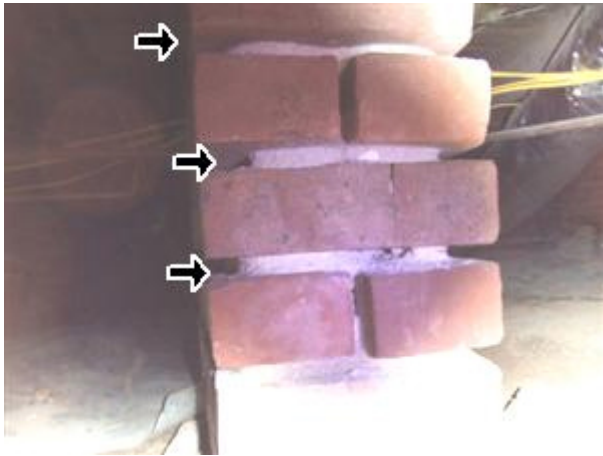
REPAIR OR REPLACE: Brick pier have deteriorated mortar and are unstable throughout the crawl space. This problem will continue to worsen if not corrected and compromise the ability of the foundation to support the building. The diagnosis of structural problems is beyond the scope of a home inspection. Recommend a qualified engineer inspect and repair or replace as needed.

11.0 Picture 1 Missing mortar

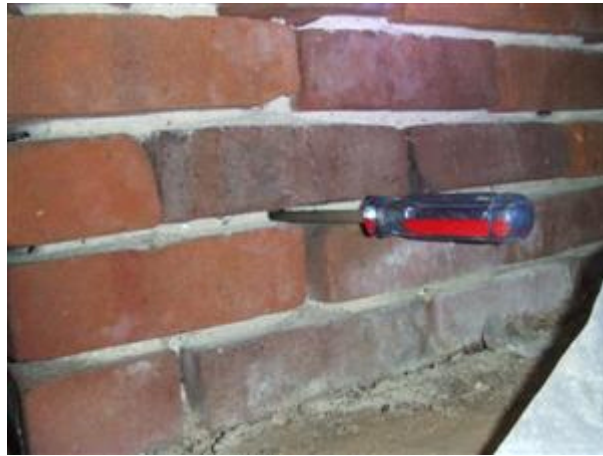
11.0 Picture 2 Screw driver 6" into soft mortar
