FINAL ANALYSIS PROPERTY INSPECTIONS

REPORT - TERMITE | MOISTURE | FUNGUS (NPMA-33 ATTACHMENT)

1234 Main Street
Virginia Beach, VA 23464

1: PHOTOS AND VIDEOS, (NPMA-33 ATTACHEMNT)

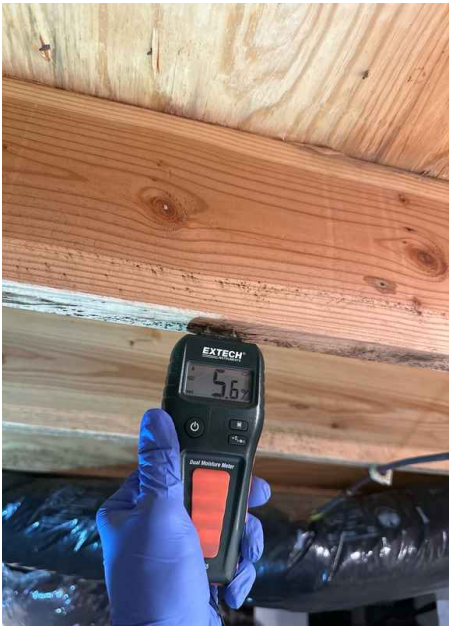
5% moisture very dry well below average, satisfactory

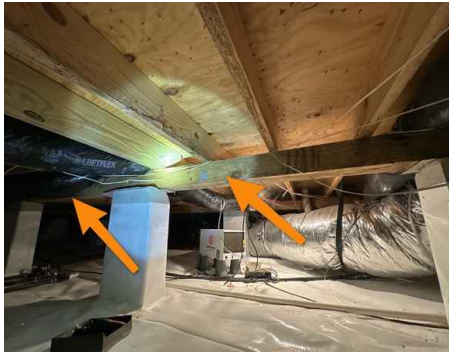
Crawlspace front under entryway

Observed approx. 10' of girder beam and 2 floor joists marked for repair.

- 1 joist and girder beams under entry way . Prior termite activity and some surface fungus growth. Termite activity did leave some surface scarring but ultimately did not enter the beam any further than 1/8". Framing not compromised or damaged. Old markings on the beams indicate this was evaluated in the past and deemed structurally OK as well.

Under front entryway, gutter beams marked with X for repair, no damages

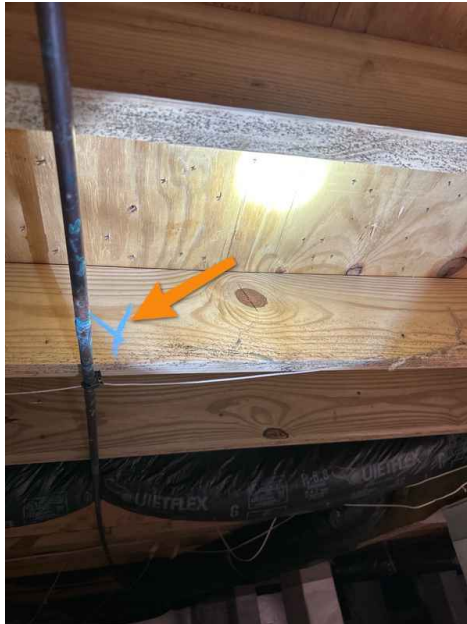
- 1 floor joist towards the left. No damages or fungus growth, some minor chip out visible, not compromising.

Floor joist under front entryway, marked with an x for repair, no damages

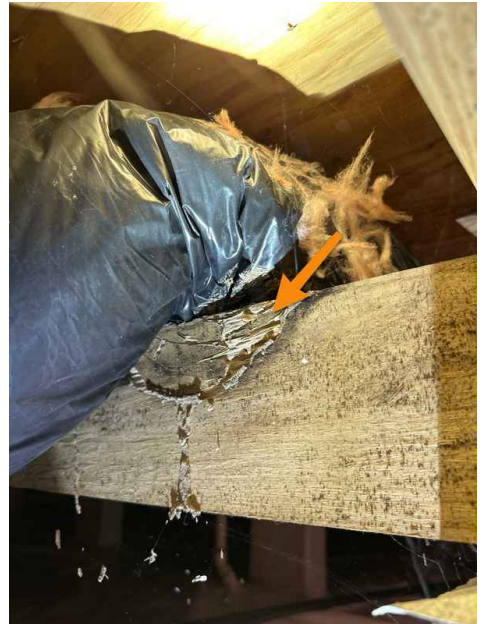
Surface scarring in areas. Not damaged or compromised

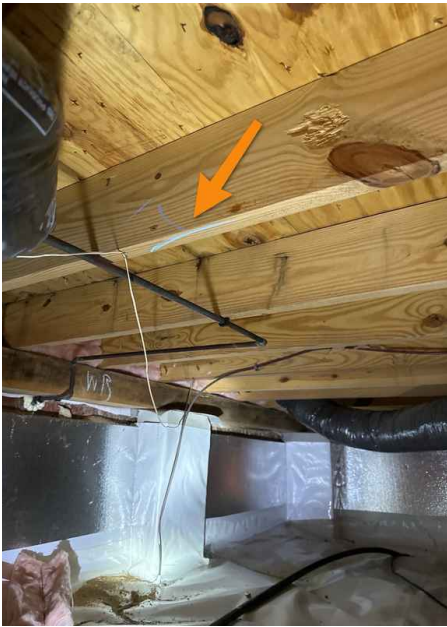
Crawlspace Front Left, marking on joist. No issues

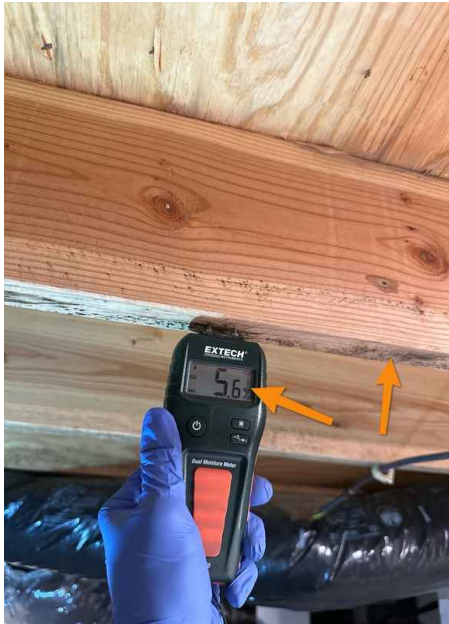
Observed surface based fungus which was inactive at 5% moisture content and is considered cosmetic, non damaging. Does not require treatments.

Surface fungus visible, inactive at 5% moisture, non-damaging type, considered cosmetic

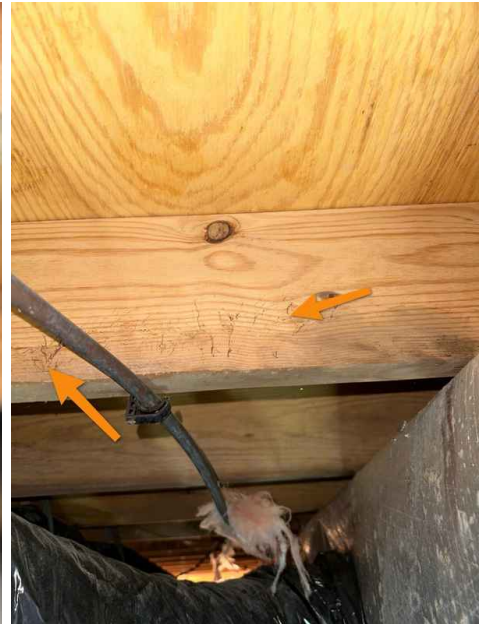
Prior damaging type fungus growth visible, inactive and wipes off

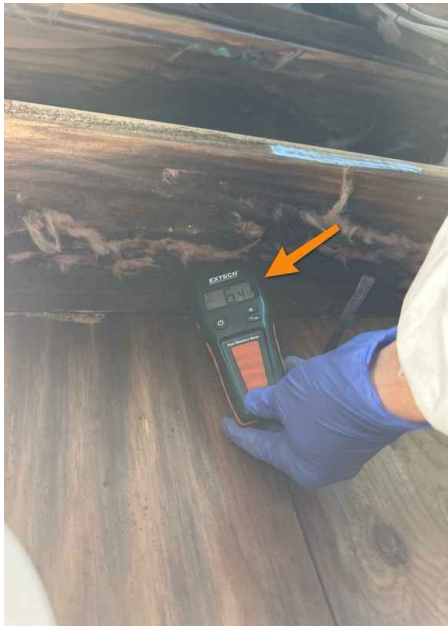
Rear under kitchen

- Notes - An old leak under the kitchen sink has caused some minor rot damages to approx. 2 floor joist, and the band joist in the area. Stained areas tested dry at 5% moisture content, leak was mitigated. Damages are minimal, no sag or crushing of the floor structure was observed. Repairs are discretionary.
- These water damages were cause by prior plumbing leak (cured) and are not applicable to the enviromental moisture/fungi condition reports.
- It was noted that approx. 4 floor joists and 4' of band joist was marked for repair by prior inspection. These areas appear structural sound and are not part of this report.

Moisture stained framing dry at 6% moisture

any work decided to be repaired should be completed by a capable framing repair contactor/rough carpentry

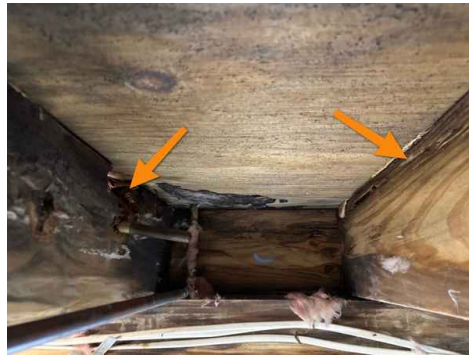
Observed old plumbing rot damages at 2 floor joist that may require reinforcement by "sistering". Some minor damage to band joist could use blocking.

2 joists damaged under kitchen sink

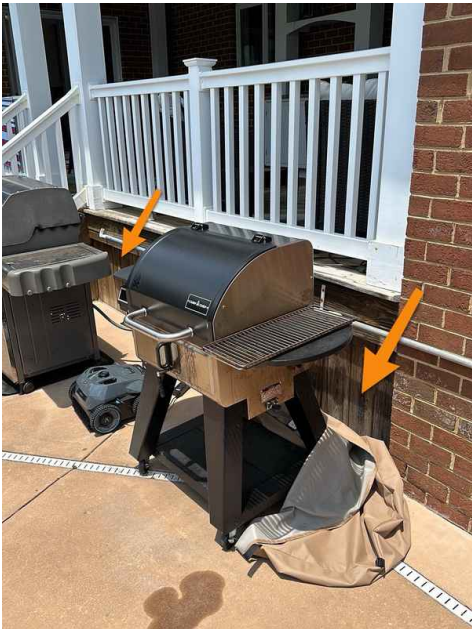
There was no visible or physical access to the deck structure at the rear. Deck structure cannot be inspected.

No access

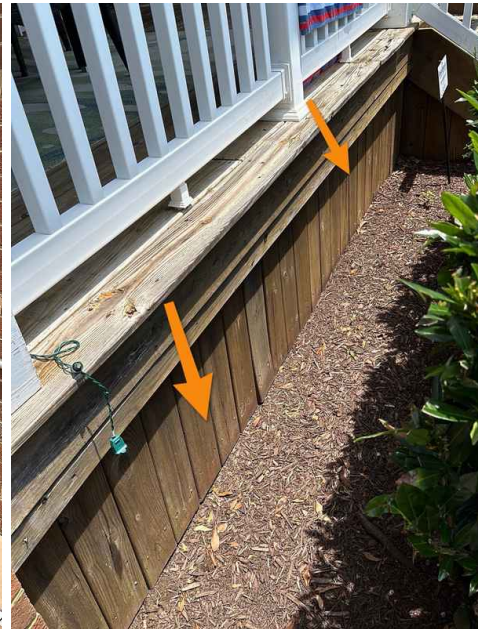
No access
