# FINAL ANALYSIS PROPERTY INSPECTIONS

## MOLD | INDOOR AIR QUALITY REPORT

1234 CopperStone Way  
Chesapeake, VA 23320

07/17/2025

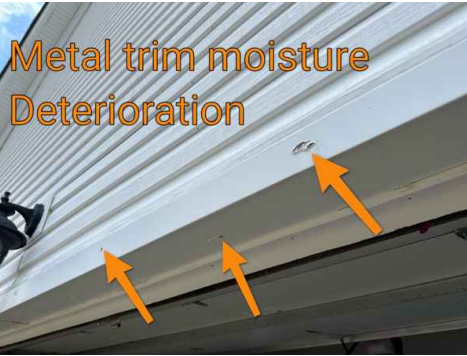
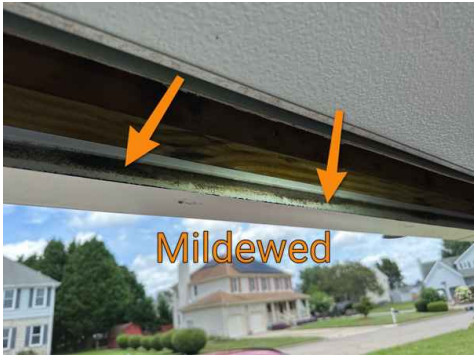
### EVIDENCE OF HIGH EXTERIOR MOISTURE LEVELS

Evidence of high moisture conditions outdoors, as evident by deteriorated metal trim work and mildew growth on garage door jamb seal. High exterior moisture can be a contributing factor for high moisture in open / vented crawlspaces and indoor locations.

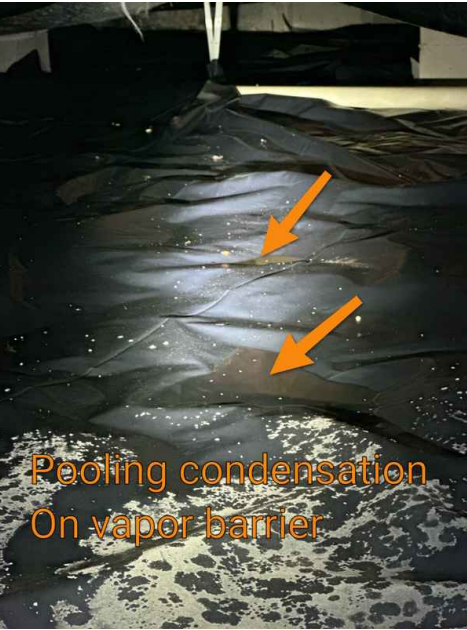
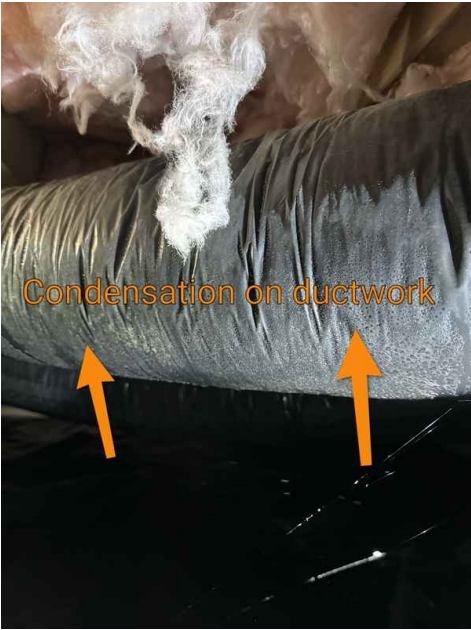
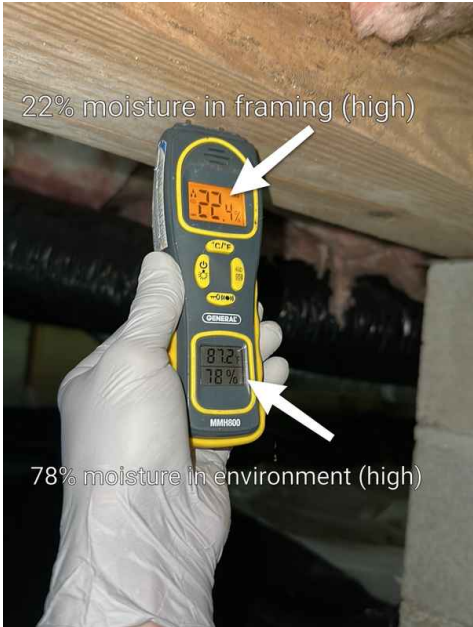
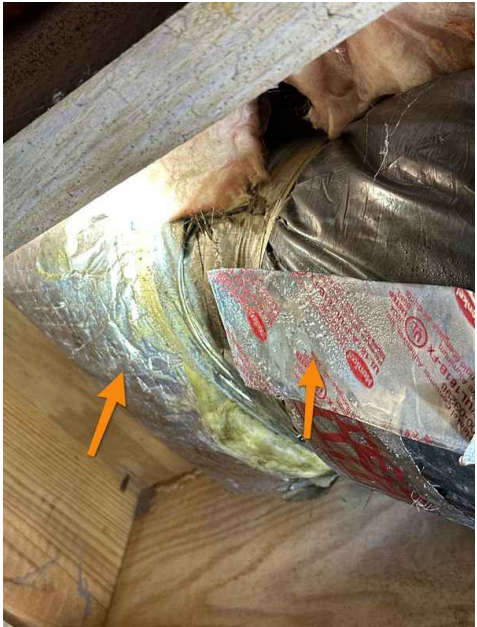
#### CONDENSATION OBSERVATIONS, HIGH SEASONAL MOISTURE CONDITIONS IN CRAWLSPACE

Observed seasonal elevated moisture conditions in the crawlspace which can contribute to indoor high humidity and mildew growth around HVAC vents. Observed high moisture levels 78% in crawlspace environment, elevated moisture levels in framing at 22% moisture, and general condensation on ductwork. It is recommended the crawlspace is dried and moisture mitigations are completed.

Recommend monitoring.

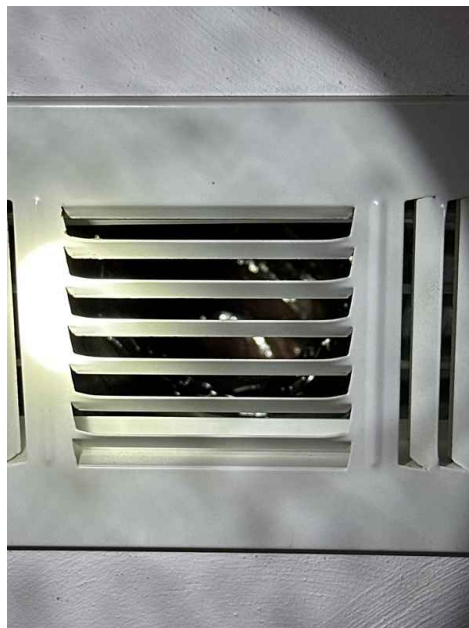
2nd Floor hvac supply ducts. Clean

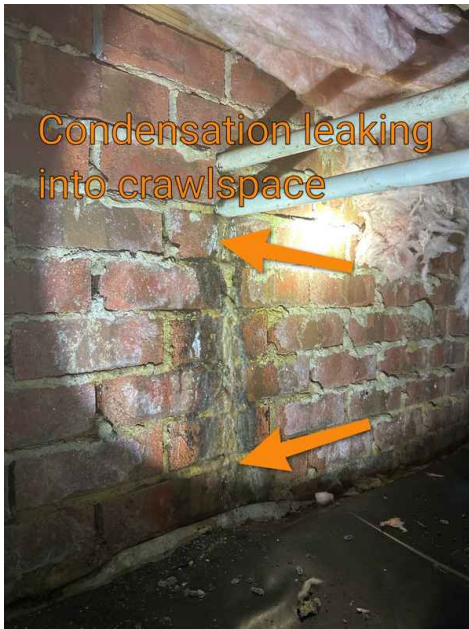
**CONDENSATE DRAIN LEAKING INTO CRAWLSPACE**

HVAC condensate drain is leaking into the crawlspace which can contribute to elevated moisture conditions. Recommend repair.

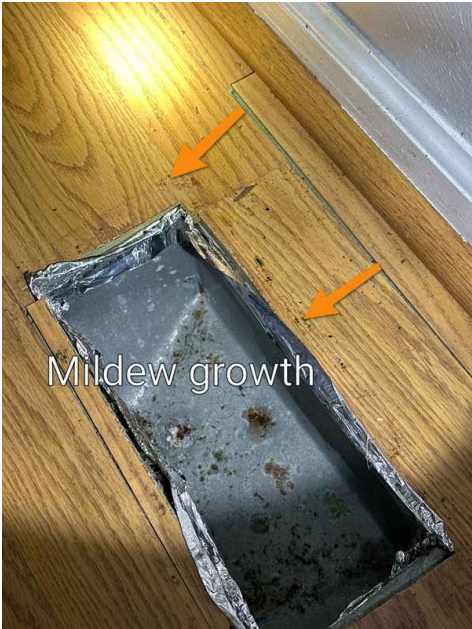
THROUGHOUT 1ST FLOOR AT SUPPLY DIFFUSERS

Visible mildew growth on the floor at the underside of the HVAC supply diffusers. Appears to be caused by elevated crawlspace moisture conditions and unsealed HVAC boots at the floor. This visible mold was sampled (see sampling section for results once available).

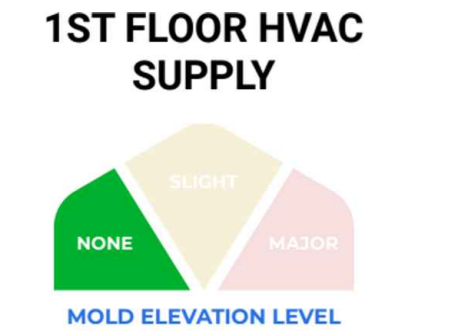
re types and concentrations of mold found in  
his sample were found to be similar to what was  
ollected in the outdoor control sample.
