Roofing/Flashings/ Chimneys

Final Analysis Property Inspection LLC

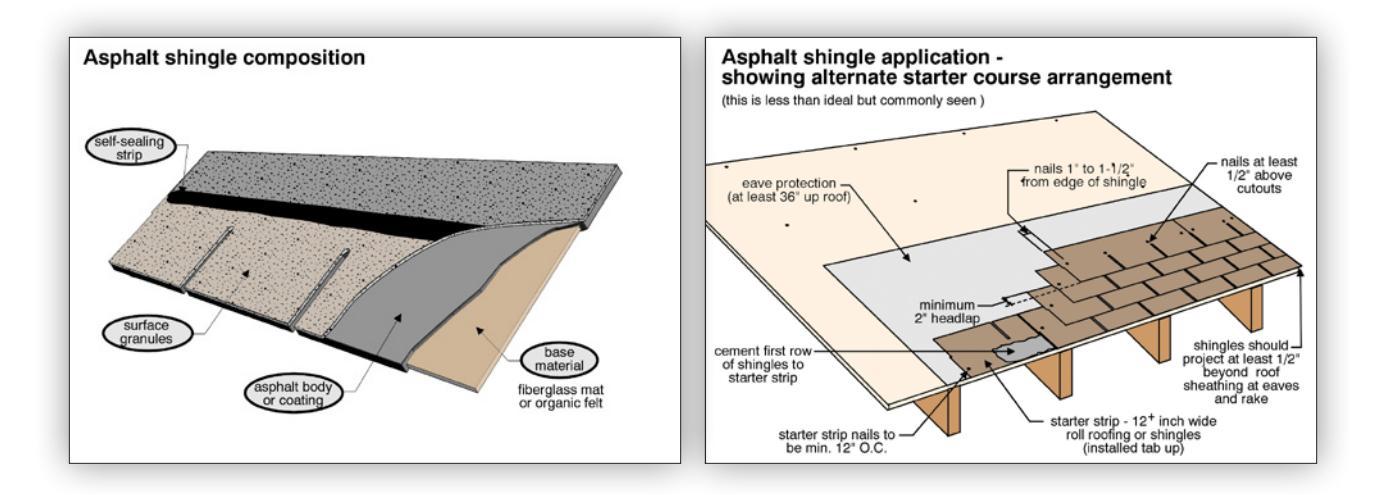
Asphalt shingles (also called composition shingles) are the most common roofing material DESCRIPTION used today. The shingles consist of asphalt-impregnated felt paper or glass fiber mats, coated with a layer of asphalt and covered with granular material.

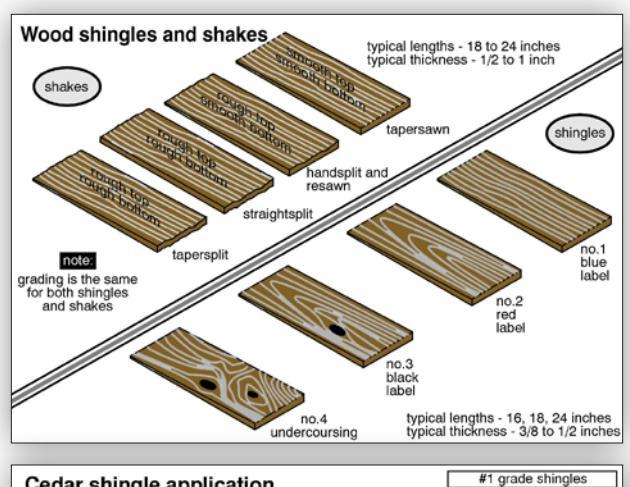
**DESCRIPTION** Wood shingles are machine cut. They are typically smaller, thinner and more uniform than wood shakes. Traditionally, wood shakes were hand split or mechanically split, although machine-sawn shakes are also available. Wood shakes are thicker and split shakes have a much more uneven surface. Most wood shingles are cedar; however, redwood and pine are also used.

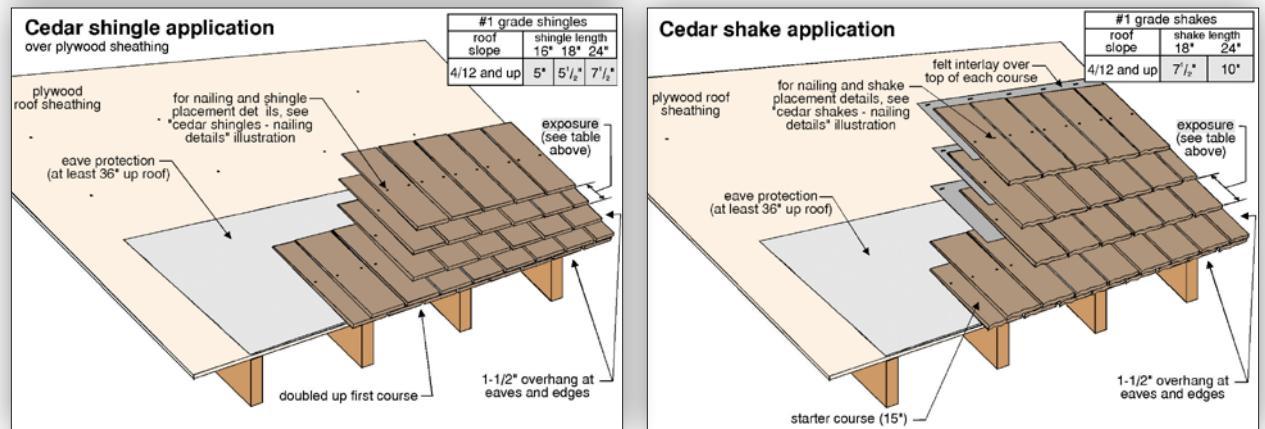
Shakes may be up to 24 inches long, with no more than half of the shingle exposed. Shakes typically have heavy building paper interwoven with the shakes to prevent wind driven rain and snow getting into the roof between the shakes.

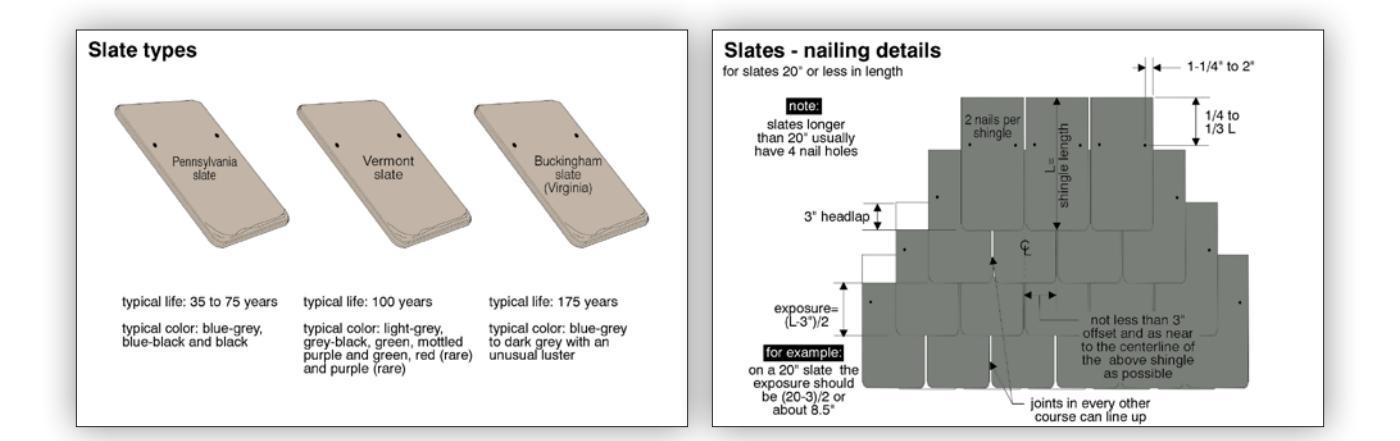
**WEAR FACTORS** While some slates are of low quality and tend to flake and shale, the biggest problem with slate roofs is often the nails holding the slates in place. With time, the nails rust and allow the slates to slide out of position. Copper and stainless steel nails last longer than galvanized nails. Once one slate has come loose, water rusts the nails holding nearby slates in place. Good maintenance is important on an older slate roof. While it is not common practice, slate roofs should be inspected and repaired at least annually. Slates that have slipped are re-secured, and slates that have cracked or split as a result of mechanical damage are replaced. As a general rule, roof replacement makes sense when more than 10% is in need of repair.

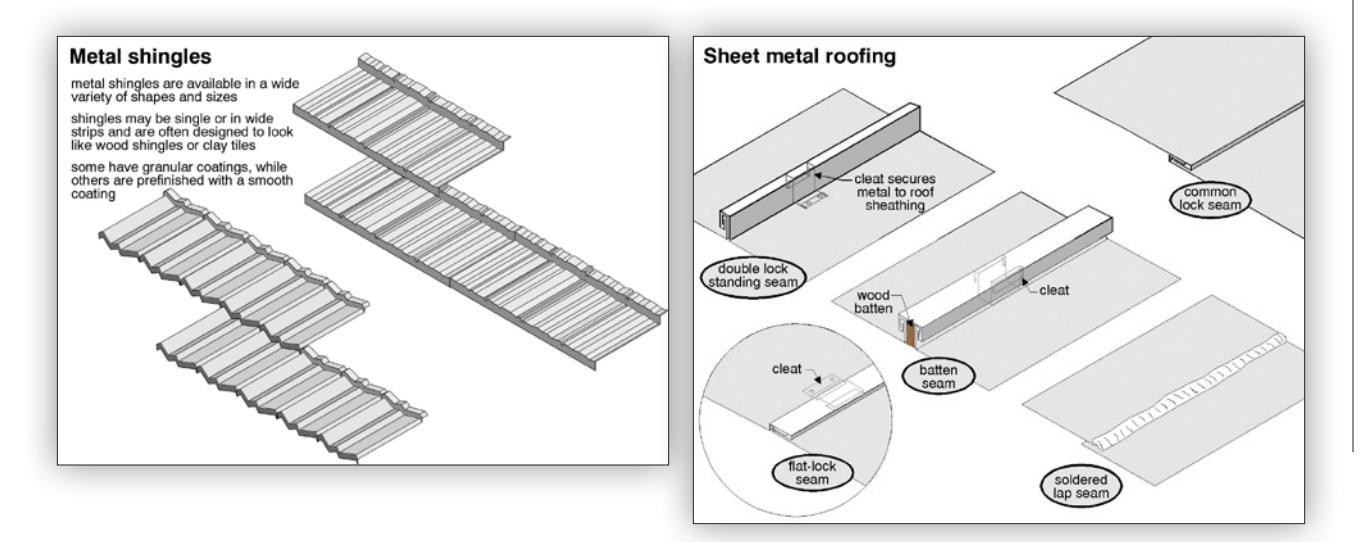
**DESCRIPTION** There are many types of metal roofs. Copper, galvanized steel, pre-painted or coated steel, terne and tin are common. Some metal roofs have a granular surface embedded in the finish. Most metal roofs (particularly copper) are expensive systems, but they last longer than asphalt shingles. They can be installed as sheets or shingles. Sheets and shingles can be used on sloped roofs; however, flat roofs are only covered in sheets. Sheet metal roofs can have different types of seams including soldered and crimped.

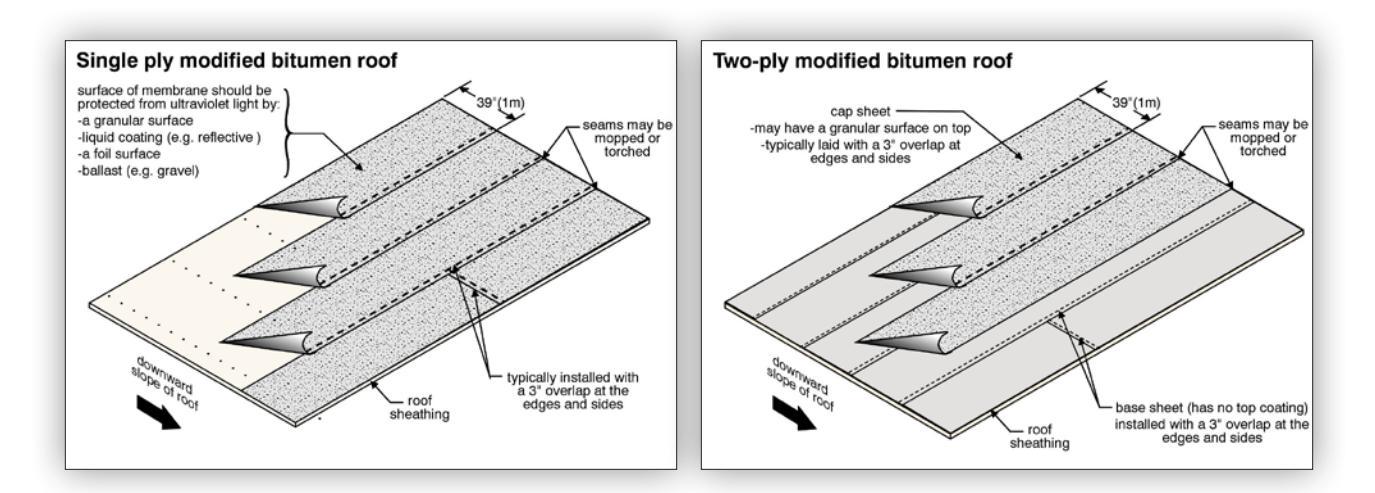
**DESCRIPTION** Modified bitumen membranes are an alternative to built-up roofs. Polymer-modified asphalt is bonded to fiberglass or polyester reinforcing to form sheets of roofing membrane. Rolls of this rubberized asphalt membrane are typically torched onto the roof, bonded (mopped in) to the roof with hot asphalt, or adhered to the roof using a peel-and-stick backing. The surface of the membrane may be protected from ultraviolet rays by a coating of granules, foil, or paint. The sheets are approximately 40 inches wide and usually overlap each other by four inches. Modified bitumen roofs may be installed as either a single or double layer system.

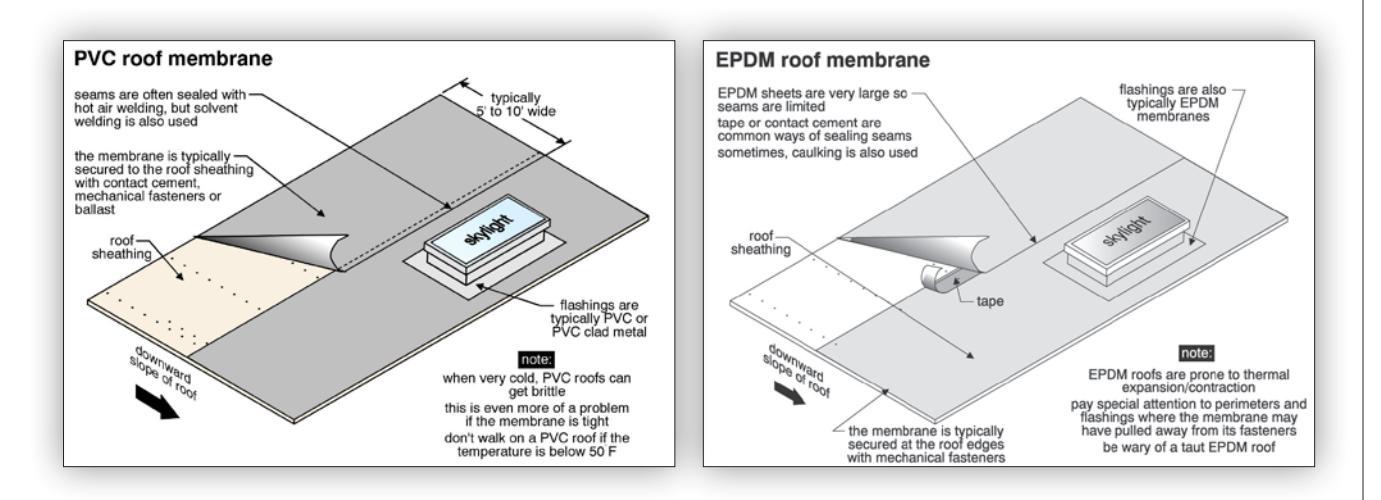
Plastic, or thermoplastic, membranes include polyvinyl chloride (PVC) and thermoplastic polyolefin (TPO). Rubber or thermoset membranes include ethylene propylene diene monomer (EPDM) and butyl rubber (polyisobutylene – PIB).

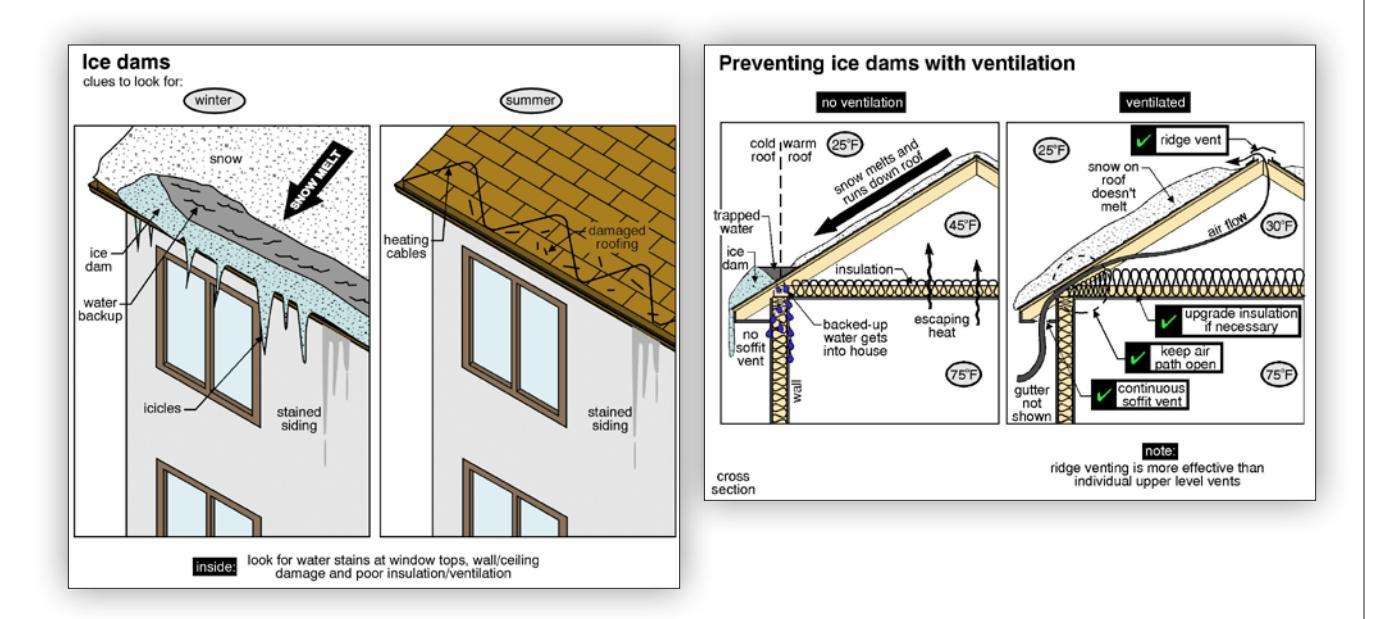
> Ice damming problems do not necessarily occur every winter. They normally occur after periods of heavy snowfall when daytime temperatures are at or slightly above freezing while nighttime temperatures are below freezing.

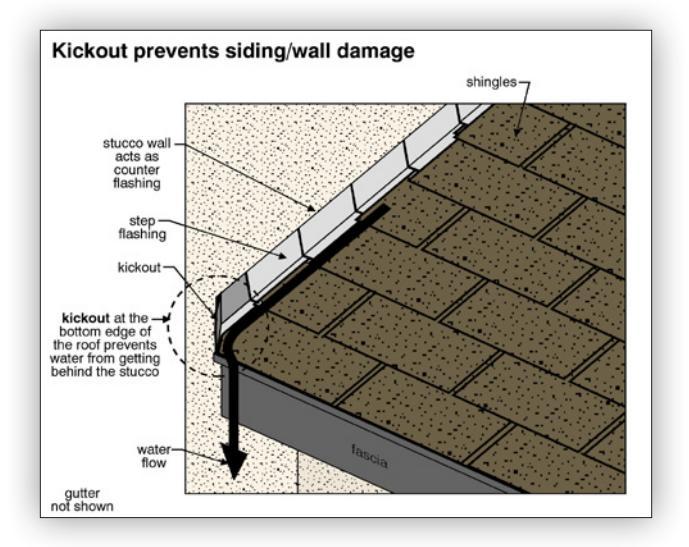
# **NO KICKOUT** This flashing should be provided **FLASHING** at the bottom of the roof that is against the side wall. Where the flashing is omitted, water may get in behind the siding and cause damage to the wall around and below the bottom of the roof.

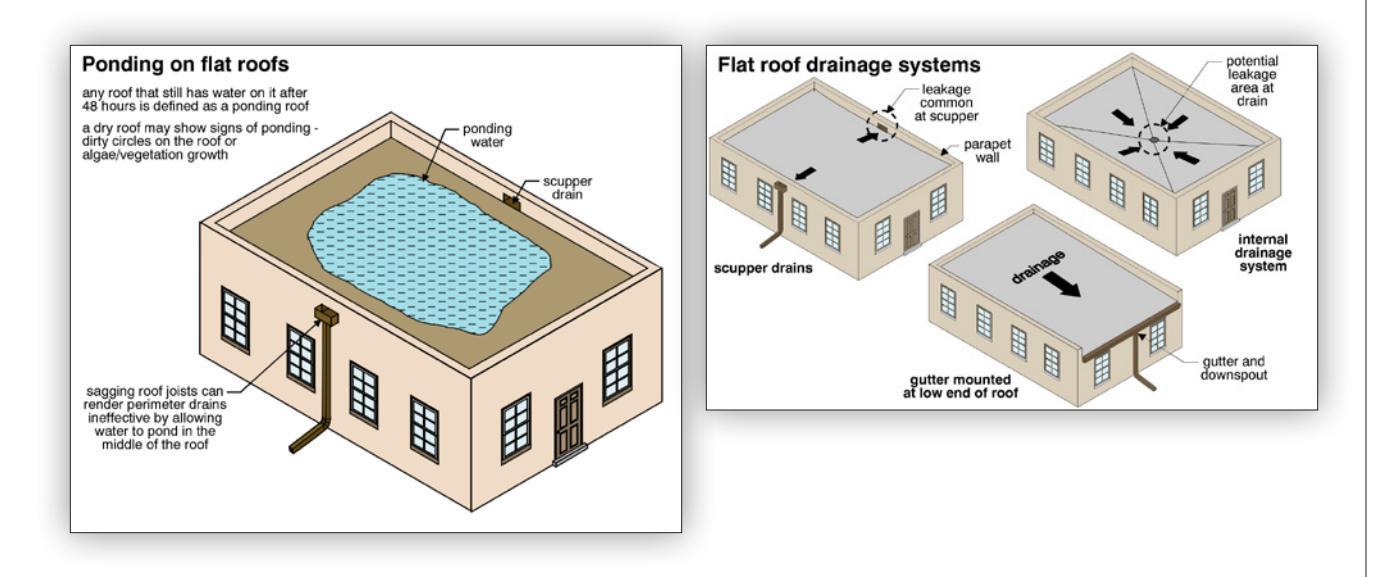
While ponding is most often caused by inadequate roof slope, it may also be the result of missing or clogged roof drains. When leaks do occur, they do more damage if there is a large volume of water ponded on the roof.

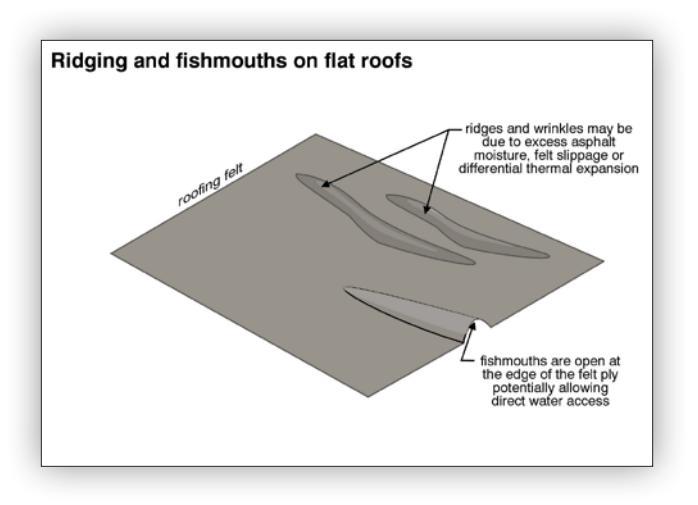
Wrinkles or ridges that create openings at seams are sometimes called fishmouths.

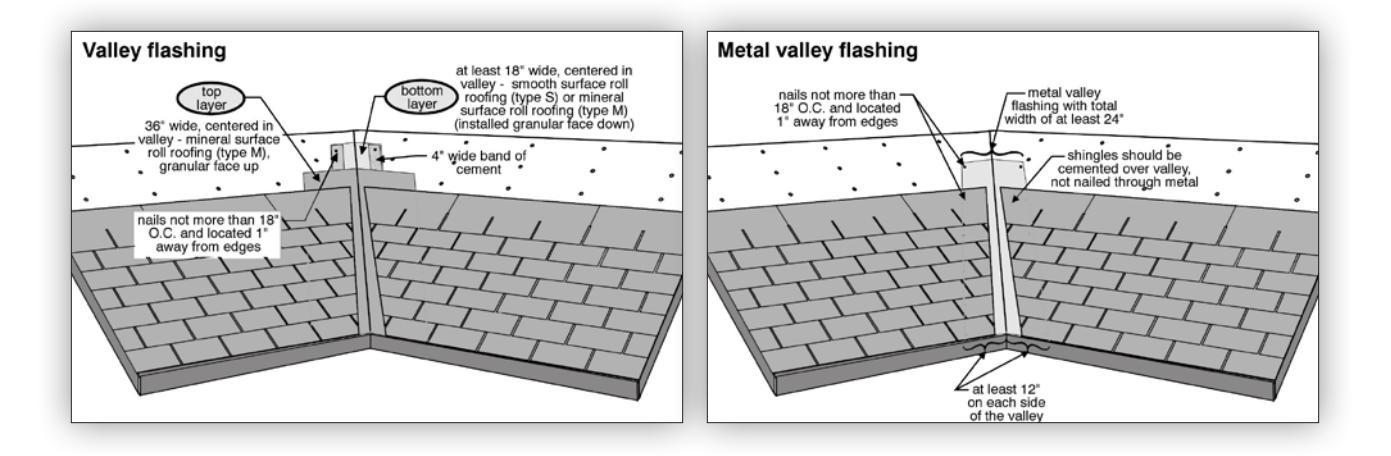
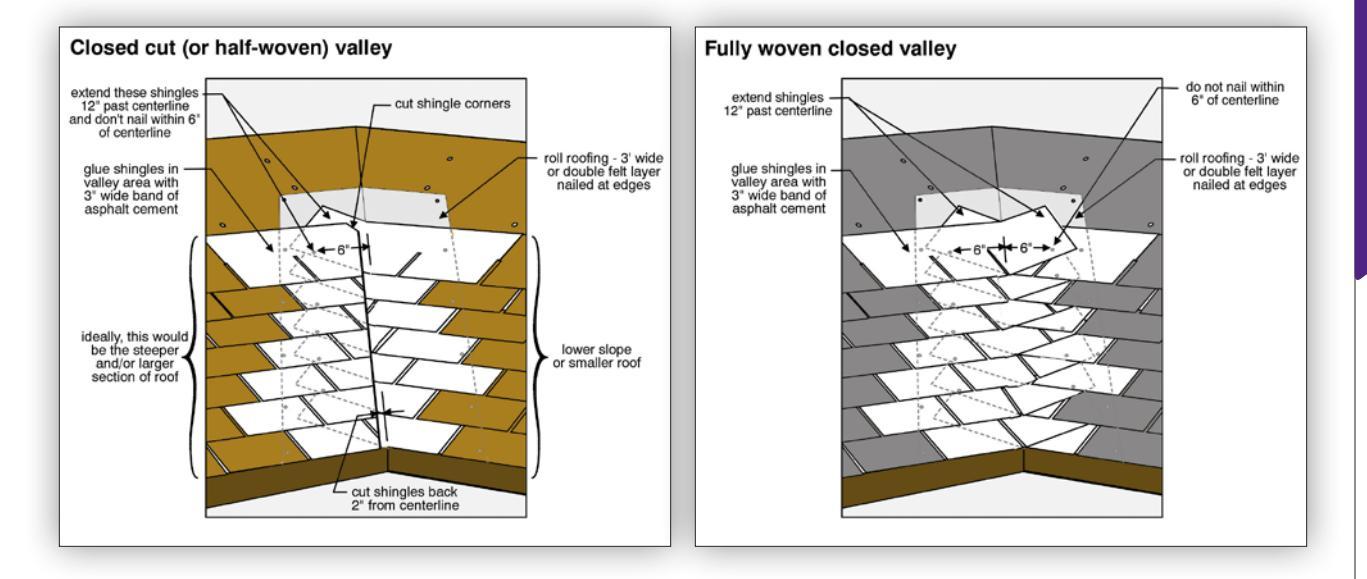
**DESCRIPTION** All valleys should have flashings. Metal valley flashings are better but more expensive than roll roofing. Where the flashing is visible, it is known as an open valley. Metal valley flashings are typically 24 inches wide; however, much of the material is hidden by the shingles. When roll roofing is used, two layers are installed; one being 18 inches wide, and the top one 36 inches wide.

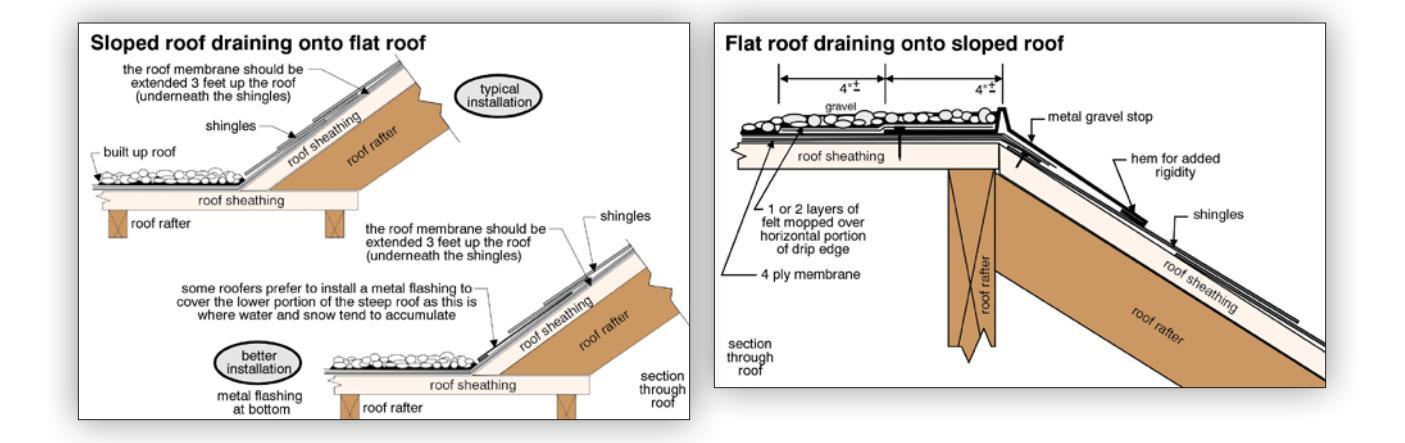
When the flat roof is below the sloped one, the flat roofing material is typically applied first and extended up the slope. The sloped roofing covers the flat membrane. There may be metal flashing used at the change in direction. When the flat roof is above the sloped roof, a metal flashing protects the top of the sloped roofing material. The metal flashing extends onto the flat roof and is covered by the flat roof membrane.

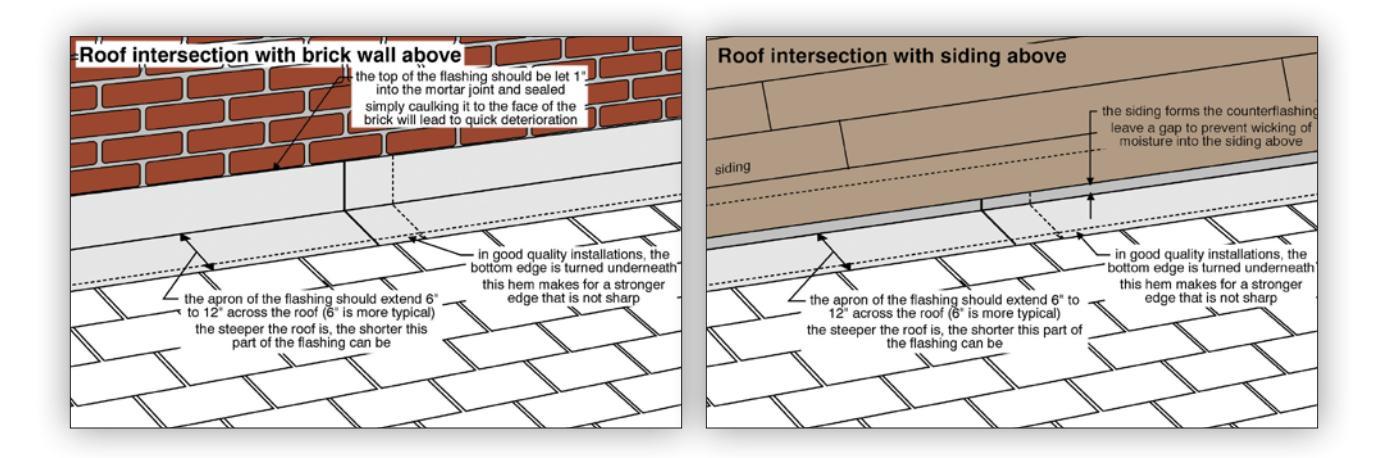
**DESCRIPTION** Special flashing is used when a roof intersects a wall. The flashing depends on the configuration and the roofing material. If the top of the roof meets a wall, a counter flashing can be installed over the roofing material. This metal skirt covers the top of the roofing material and extends up the wall behind the siding. On masonry walls, the metal flashing is let (embedded) into a mortar joint or sealed to the masonry surface with caulking (the less desirable approach).

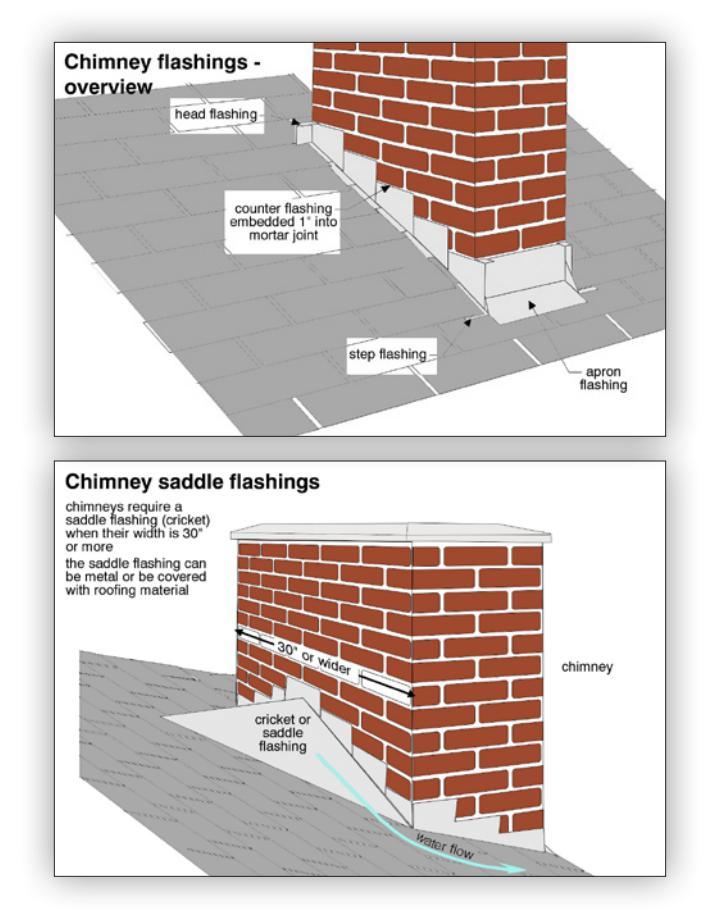
> When a chimney is more than 30 inches wide, a saddle (or cricket) should be used to divert water around the chimney. This is a small peaked roof that directs water around the chimney.

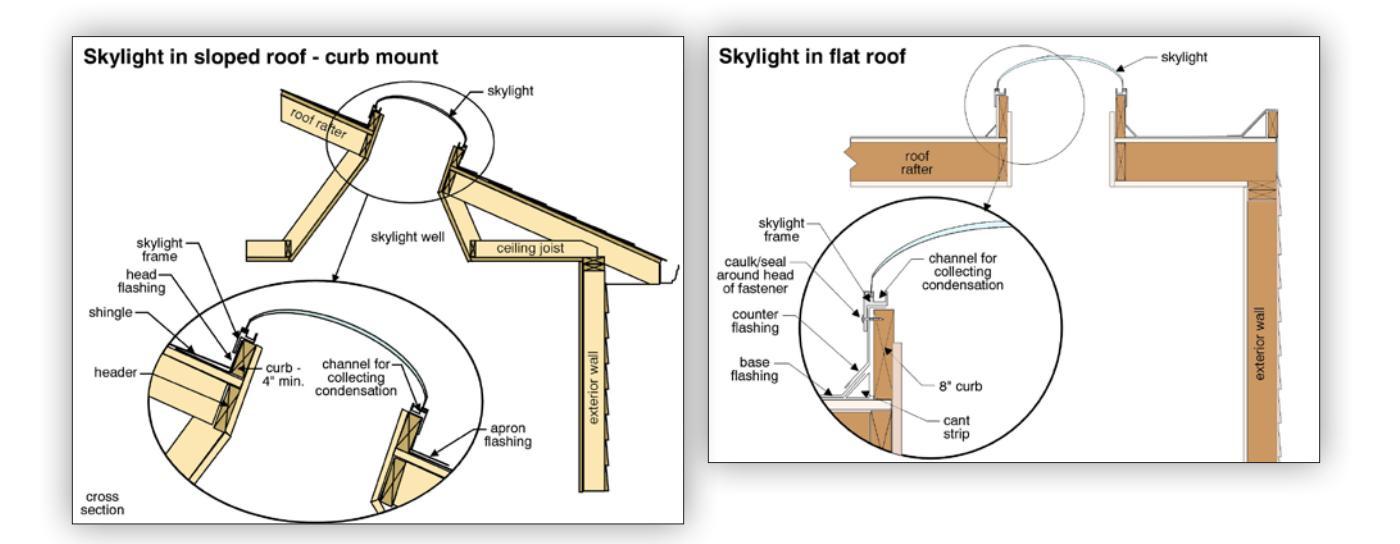
Skylights should be flashed much like chimneys. A skylight should be installed on a curb or box that protrudes above the roof surface (unless the skylight comes with a premanufactured flashing assembly). This allows for the installation of proper flashings and limits snow accumulation on the skylight in cold climates.
